House
118 Hays Street
Bel Air
private

HA-1412
1314125704

INVENTORY FORM FOR STATE HISTORIC SITES SURVEY

HISTORIC SITES SURVEY FIELD SHEET
Individual Structure Survey Form

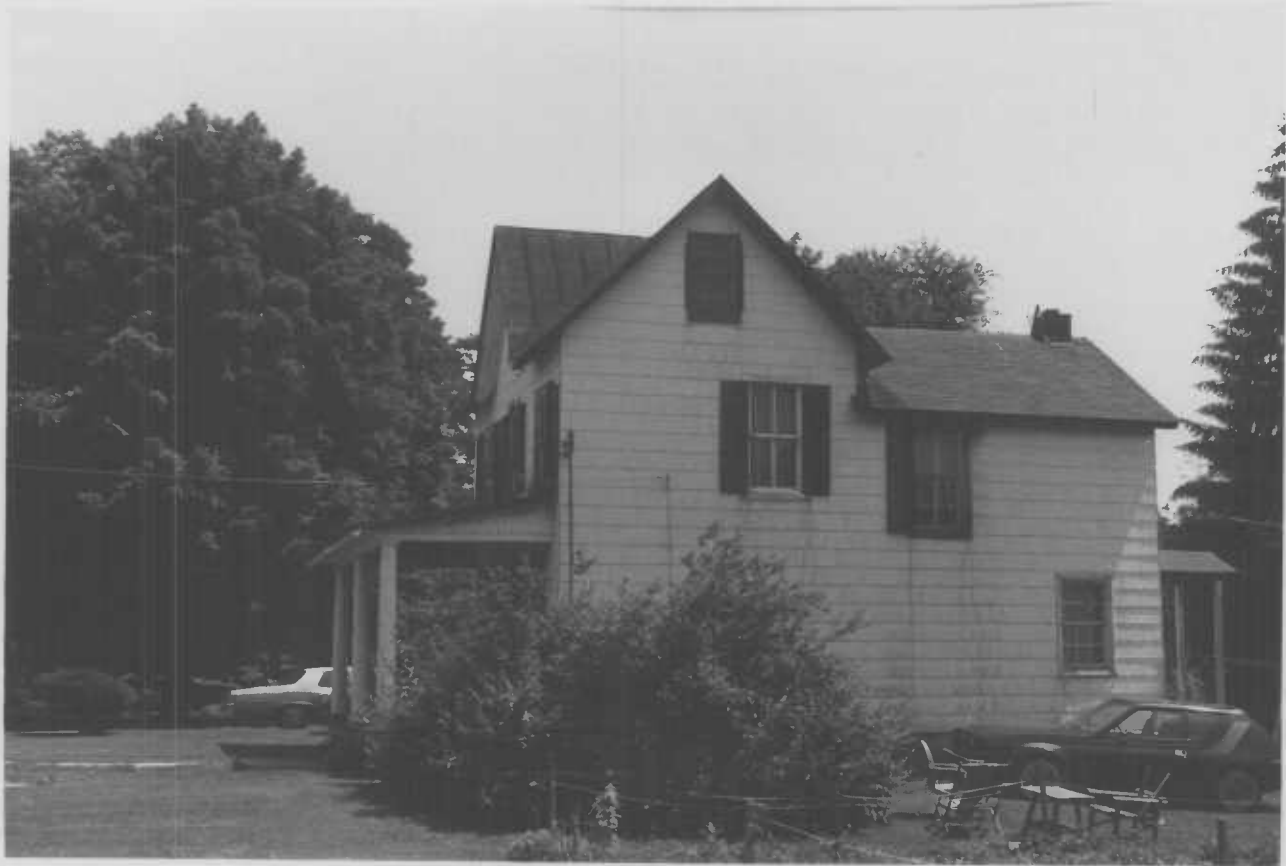
HA-1412 House, 118 Hay St, Belan
e+n clw
M. Larew, 1979

This two and a half story L-shaped house with a gable roof is at 118 Hays Street in the Town of Bel Air, Harford County, Maryland. Its asphalt shingle siding and metal roof are in poor condition. The ridges of the roof meet at right angles, giving the house gables at the back (west) of the ell and on the north and south sides. A front, decorative gable has a round arched 2/2 double-hung sash window in it. The rest of the windows in the main block are also 2/2. The ell has some 6/6 windows. The different fenestration could be replacement windows, a normally less elegant back building, or even, since this house was probably moved to this site after 1930, the joining of two separate houses. The front porch (east elevation) is supported on doric columns; the spandrels end in a saw-tooth pattern. The back (west) porch has a gable roof on plain posts. The door in the north bay of the east elevation is topped by a two pane transom. Two plain capped chimneys, one in the peak of the south (side) gable and one in the ell gable, complete the structure.

More stylish than most in Hays Addition despite its very bad condition.
